Machinery Messages

Case History

ADRE® for Windows saves a generator

by Mogens Greve
Engineer B.S.C.M.E.
Asnæs Power Station
Denmark

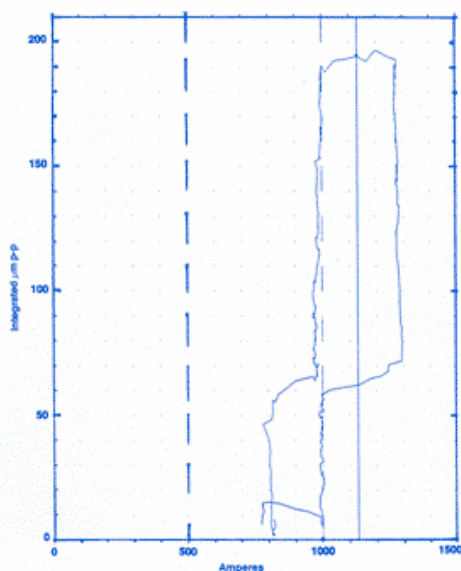
Figure 2:

We increased rotor exciter current from 800 to 1300 amperes, and after approximately 30 minutes, we saw a corresponding increase in 1X vibration with a constant phase angle (Figures 2 and 3). 1X vibration was dominant in Unit No. 1, especially on its generator bearings, Bearings 4 and 5. From this, we concluded that the high vibration was originating in the generator.

Exciter current versus Bearing 4 vertical velocity transducer vibration. Approximately 30 minutes after exciter current is increased from 800 to 1300 amperes, vibration increases.

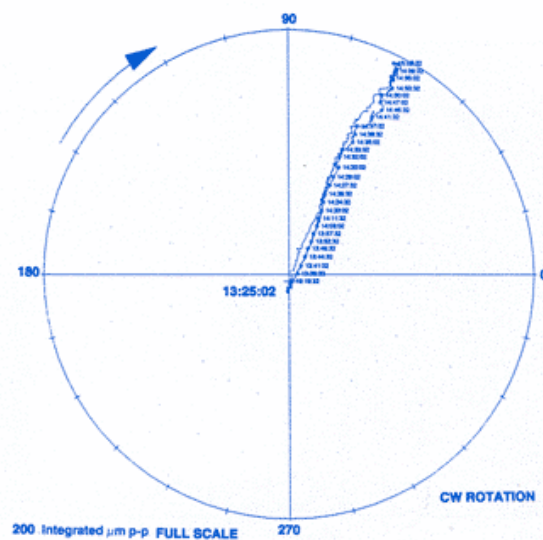
Figure 3:

Same data as Figure 2. As exciter current is increased from 800 to 1300 amperes, vibration at Bearing 4 increases with no change in phase angle.

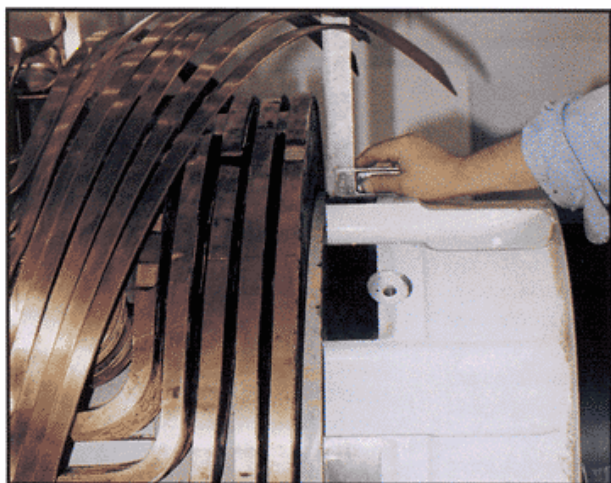
When we inspected the generator rotor, we saw that the generator windings were displaced axially by approximately 10 mm (394 mils) (Figure 5). The winding coils at one pole were pressing toward the retaining ring backplate, yielding unsymmetrical axial forces that preloaded and bent the rotor body, causing the increased 1X vibration. Further axial displacement could have led to a winding short circuit, as two of the windings were close to each other. This could have caused a more severe generator failure.

Figure 5:
Disassembled generator, viewed from non-driven end. The winding coils are pulled toward the driven end. The retaining ring has been pulled back to reveal the windings. The top winding is the damping coil, shown partially disassembled.

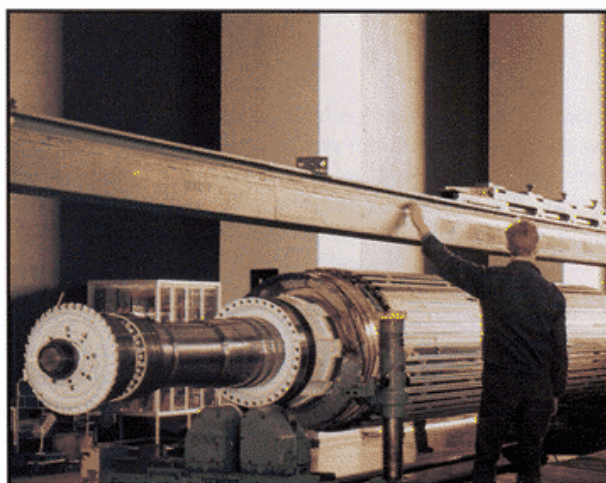
Figure 6:
Generator rotor with dismantled retaining rings.

The rotor is currently under repair at Asnæs Power Station (Figure 6). Three OEM specialists and 18 Asnæs Power

Station employees are working in three shifts dismantling, straightening and reinstalling 12 of the 16 winding coils. We are modifying the bearing housing to reduce its structural resonance. **We also decided that we need better vibration information than can be provided by seismic, housing-mounted probes. On machines with fluid-film bearings, much of the energy generated by machine malfunctions is not transmitted to housing-mounted transducers. Proximity probes that directly observe the rotor provide much better diagnostic information. Therefore, in addition to seismic probes, we are installing XY proximity probes on each bearing.**

After repair, the rotor will be transported to the manufacturer for balancing. Asnæs Power Station staff will field-balance the unit using Bently Nevada's ADRE® for Windows Software, 208 DAIU and Multiplane Balancing Software.
